NMR Pipetector Test Report

◆ Domestic cold-tap water pipe at a 20-year-old apartment, PLP pipe◆

Japan System Planning Co., Ltd.

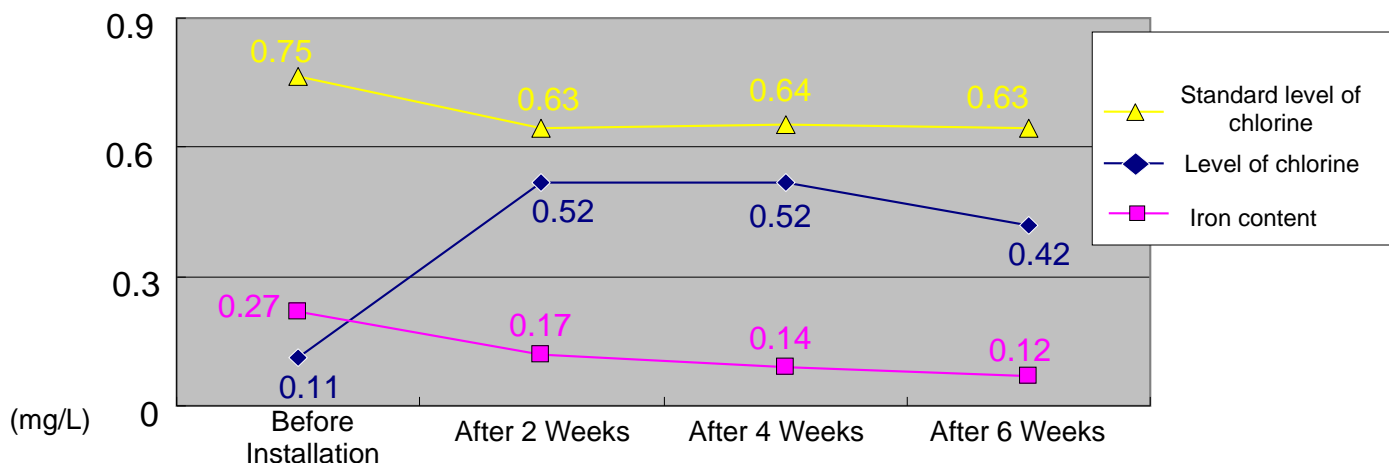
◆ Water analysis

Before Installation	After 2 Weeks	After 4 Weeks	After 6 Weeks
Standard level of chlorine in water	0.75	0.63	0.64	0.63
Level of chlorine in water	0.11	0.52	0.52	0.42
Iron content	0.27	0.17	0.14	0.12

A 20-year-old apartment had issues regarding corrosion inside its domestic cold-tap water pipework. An analysis revealed levels of chlorine concentration at 0.11 mg/L and iron content at 0.27 mg/L in the water we sampled. From these results, we realized that the level of chlorine dropped as iron content rose due to internal corrosion in water pipes.

When we sampled the water after 2 weeks of the NMR Pipetector installation in the same conditions as before, the level of chlorine went up to 0.52 mg/L and the iron content dropped to 0.17 mg/L. After 6 weeks, the level of chlorine maintained at 0.42 mg/L, whereas iron content decreased even more to 0.12 mg/L.

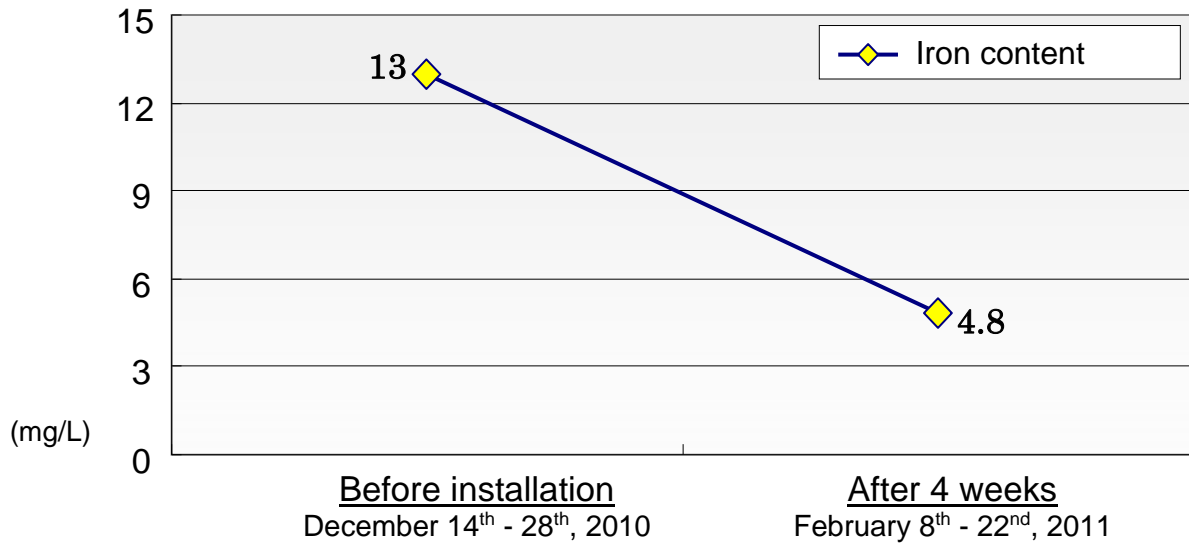
◆ Iron content captured in the filter

Before installation Dec. 14 th - 28 th , 2010	After 4 weeks Feb. 8 th - 22 nd , 2011
Iron content (mg/L)	13 mg/L	4.8 mg/L

We attached a white filter to a water tap in a bathtub before installing NMR Pipetector. After 14 days, the filter discolored to yellowish-brown with iron particles dissolved in the water, and the level of iron content in the filter was 13 mg/L. It revealed serious deterioration caused by corrosion inside the tube.

When we attached another white filter after 4 weeks of the installation in the same conditions as before, the discoloration rectified, and iron particles were hardly seen. The level of iron content also declined to 4.8mg/L.

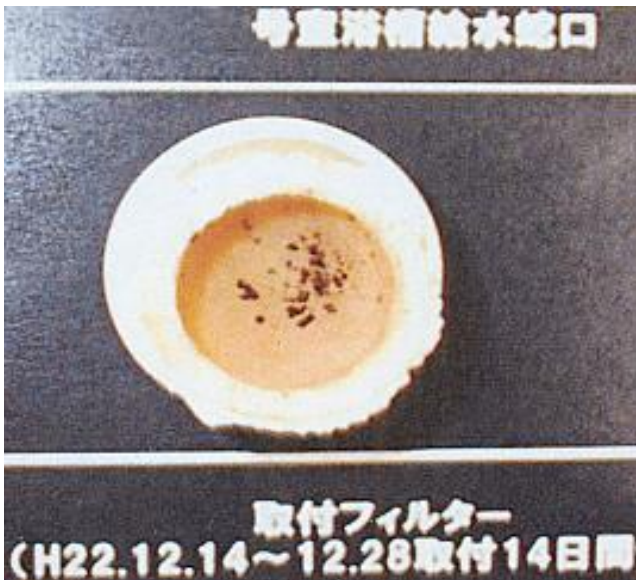
Before the installation
 Attached for 14 days from Dec. 14th to 28th, 2010
 Entire filter discolored to yellowish-brown with corrosion particles captured inside.

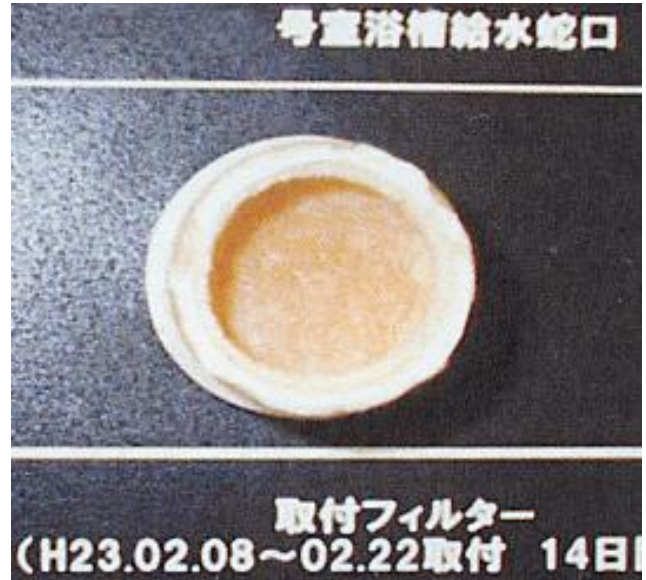
After 4 weeks
 Attached for 14 days from Feb. 8th to 22nd, 2011
 Discoloration improved.
 Many corrosion particles previously captured in the filter are now rarely been seen.
 Iron content in water dropped.
